**CAREFULLY CHECK YOUR MOORING LINES
- WEAKNESSES MAY NOT BE OBVIOUS**

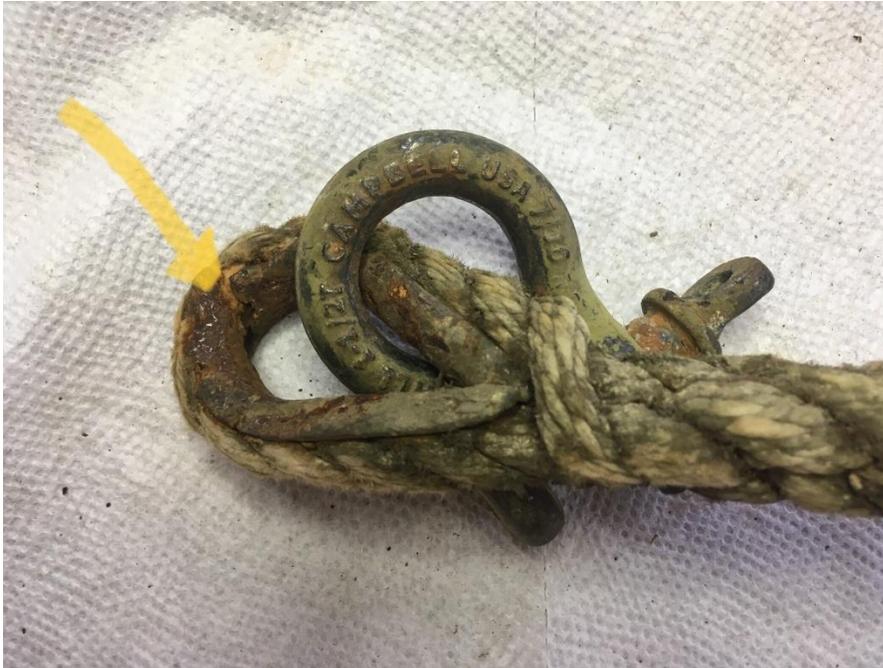
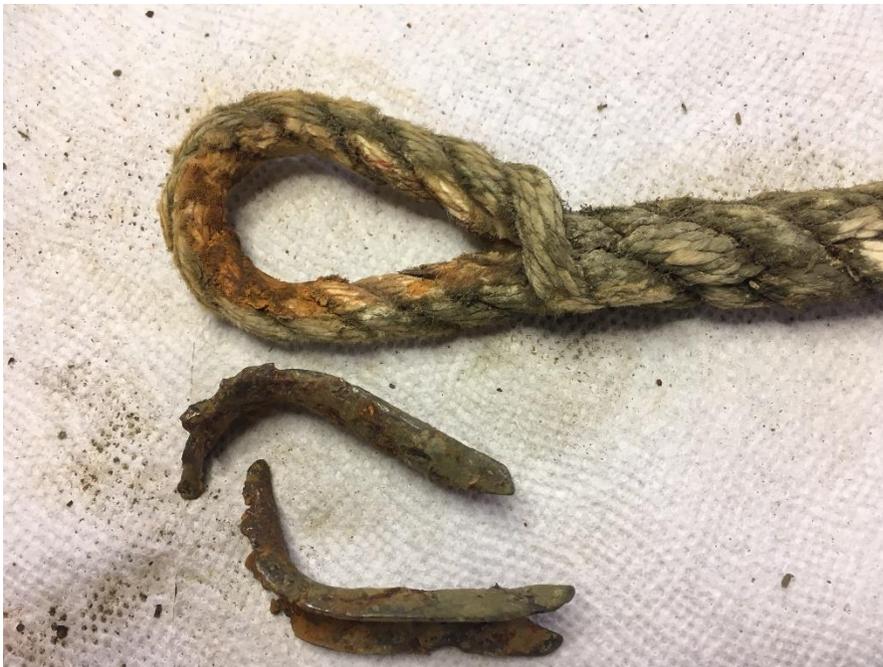
This illustrates how hidden a defective line can be. Thimble was rusted and worn through to the point where chafing resistance to the shackle was about gone. Only a matter of time until the nylon line wears through.
